# Inspection Report

**Property Address:**  
5,000sf House  
Overland Park KS 12345

### ESI Property Inspection

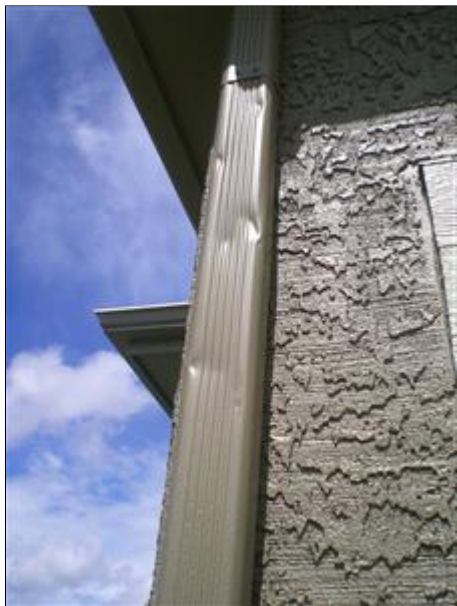
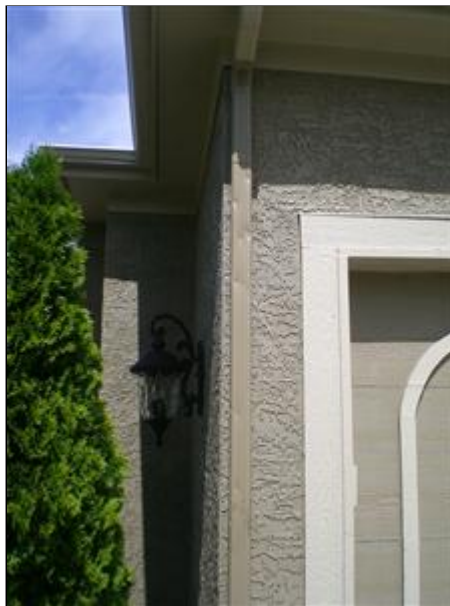
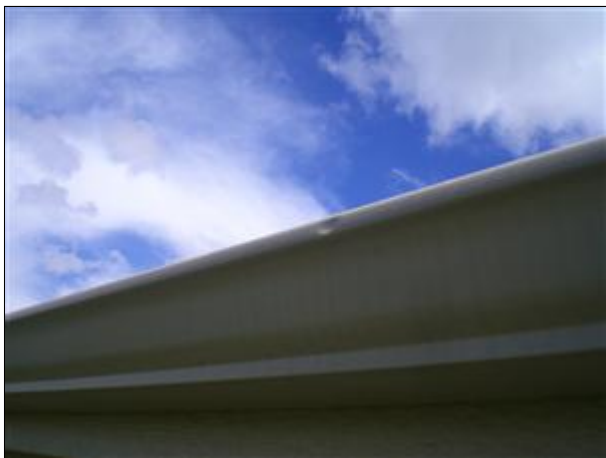
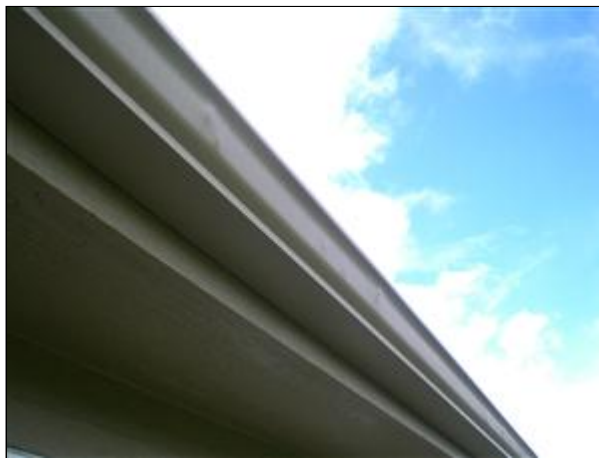
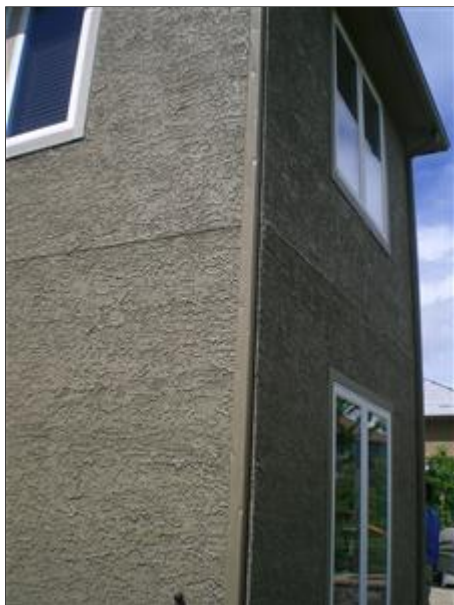
(1) Much of the gutter and downspout system is damaged by hail. Recommend replacement.

2. (1) Much of the gutter and downspout system is damaged by hail. Recommend replacement.
3. (2) Downspout at back needs a splash block to properly divert water away from the foundation.

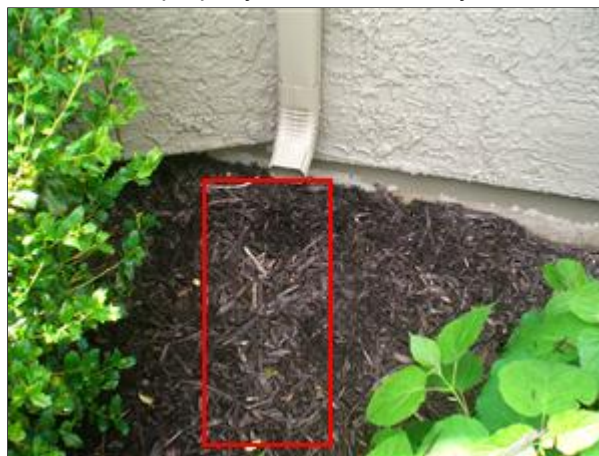
1.3 Picture 6

(2) Downspout at back needs a splash block to properly divert water away from the foundation.

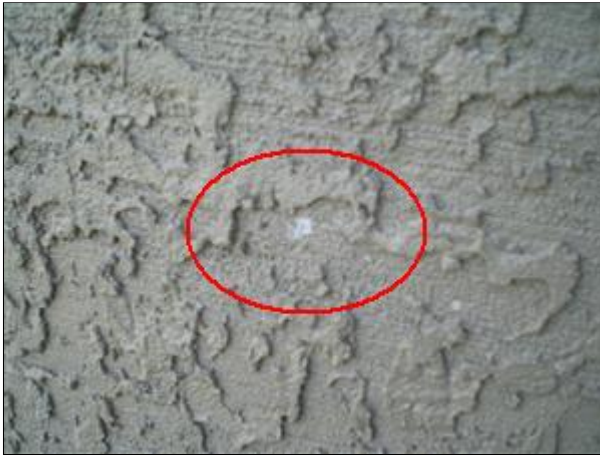
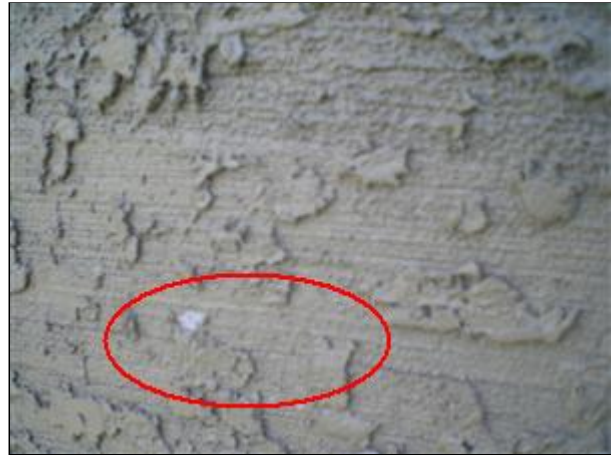
(1) There is evidence of hail damage at much of the stucco siding. Recommend re-painting to properly protect the siding.

4. (1) There is evidence of hail damage at much of the stucco siding. Recommend re-painting to properly protect the siding.
5. (2) Trim at front entry way is hail damaged and needs to be repaired.
6. (3) Trim around garage window at front is hail damaged. The top edge and base also need to be re-caulked.

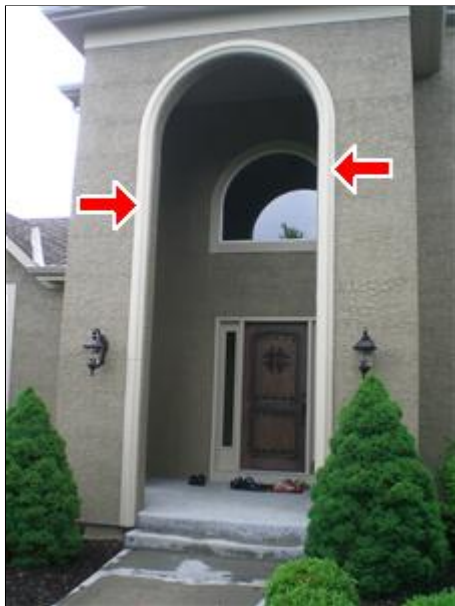
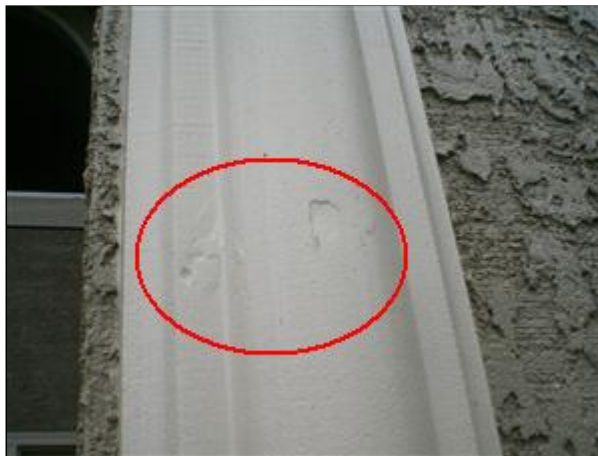
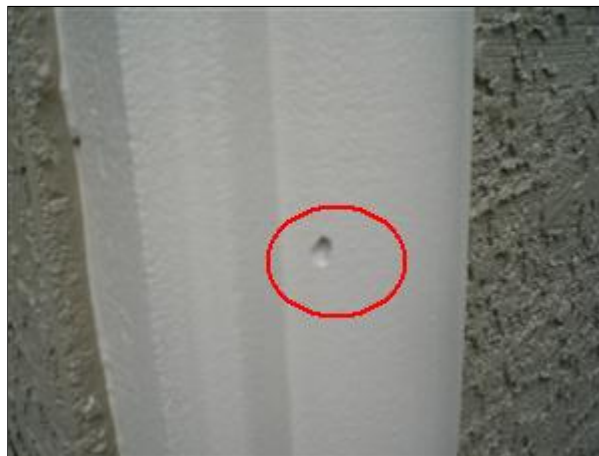
(2) Trim at front entry way is hail damaged and needs to be repaired.

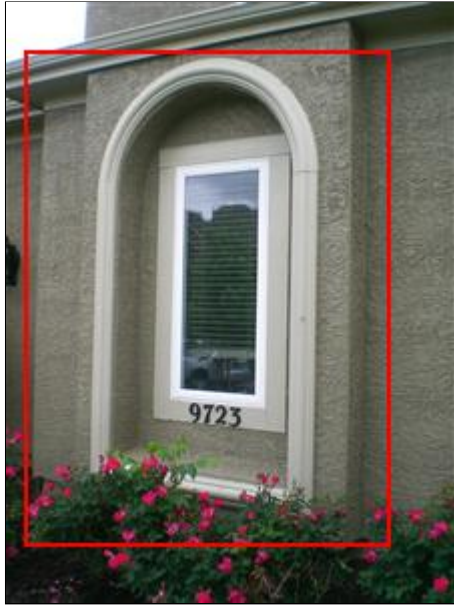
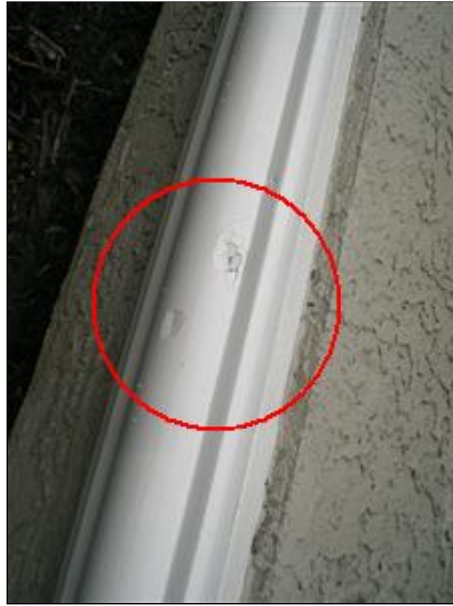
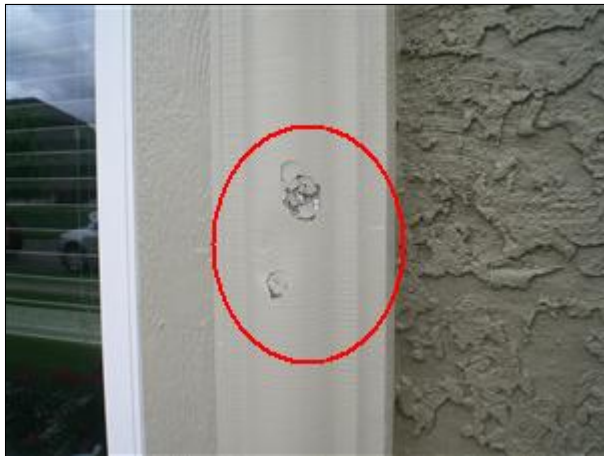
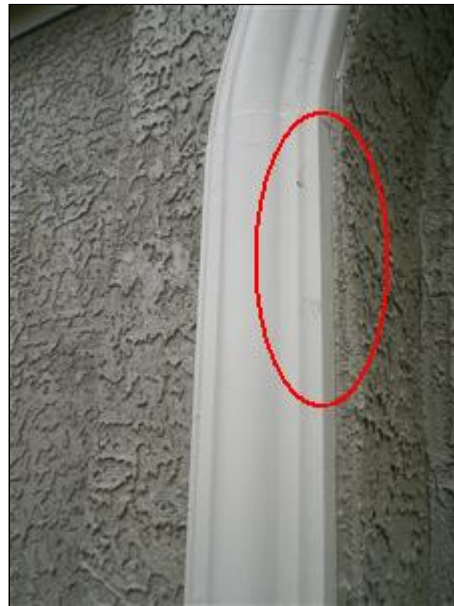
(3) Trim around garage window at front is hail damaged. The top edge and base also need to be re-caulked.

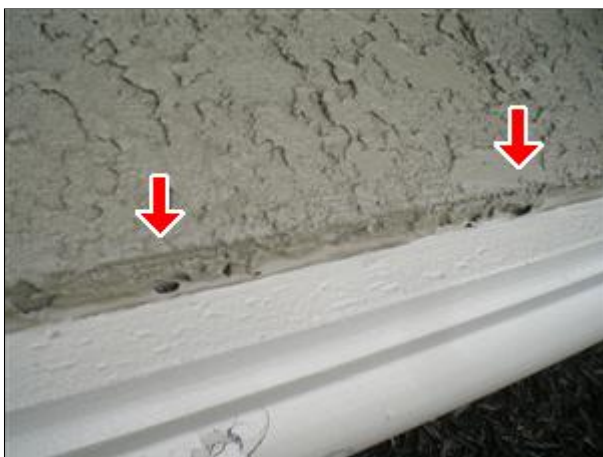
2.0 Picture 10 re-caulk bottom edge

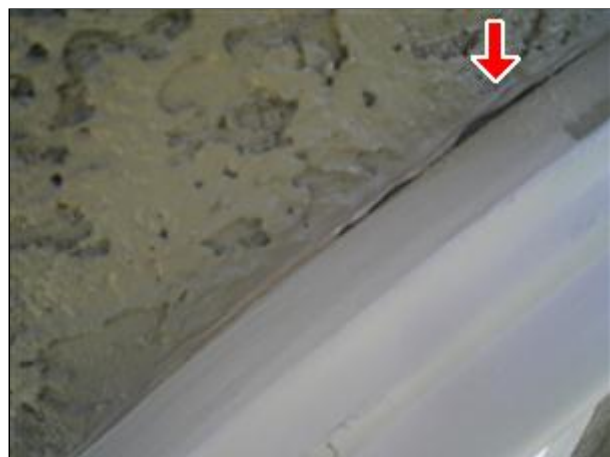
2.0 Picture 11 re-caulk top edge

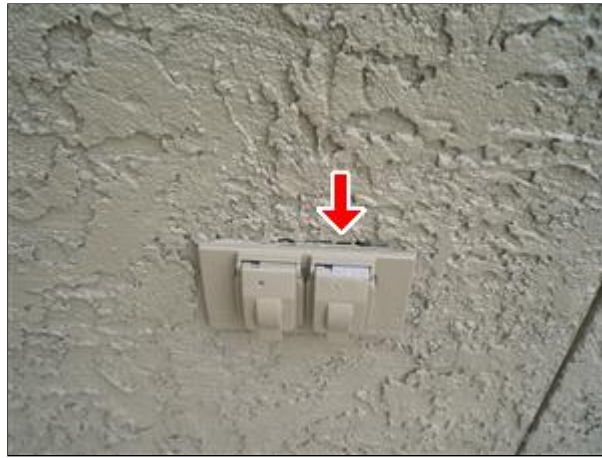
2.0 Picture 12

(4) Exterior rear electrical outlet need to be caulked at top.

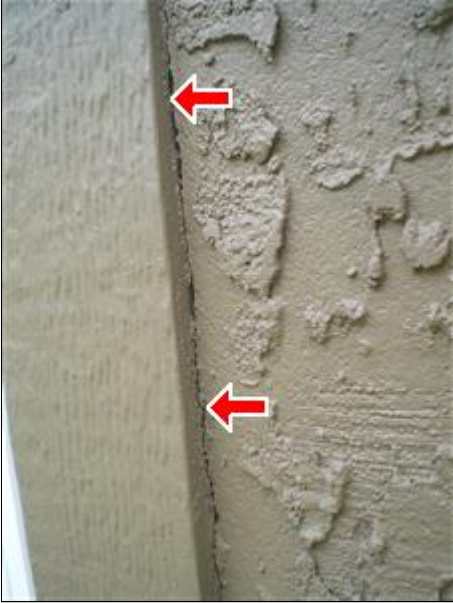
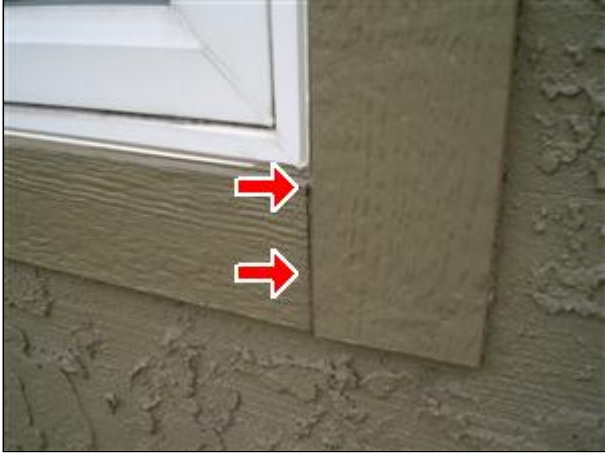
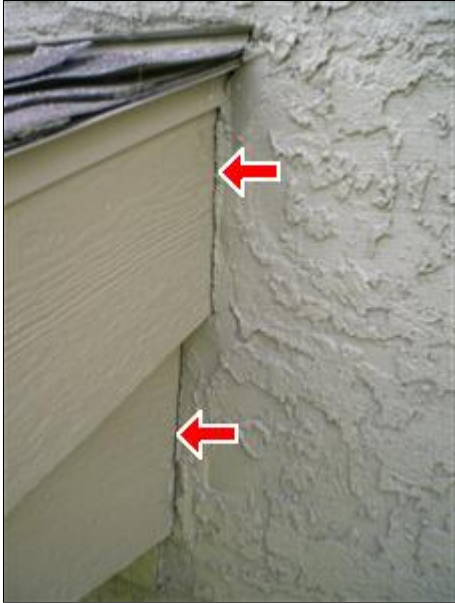
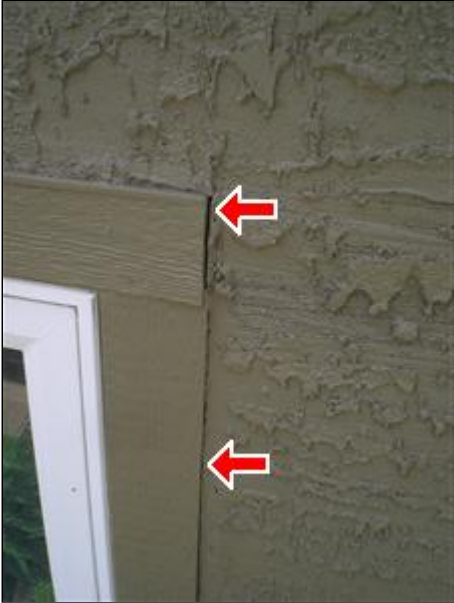
(5) To insure the longevity of window trim, it is important to keep all joints caulked and painted. Joints between trim and stucco also need to be caulked to prevent water from entering the structure. I recommend it be part of yearly maintenance to caulk and paint as needed.

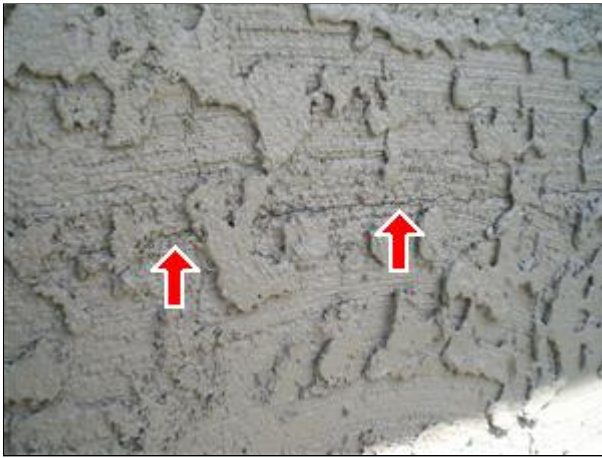
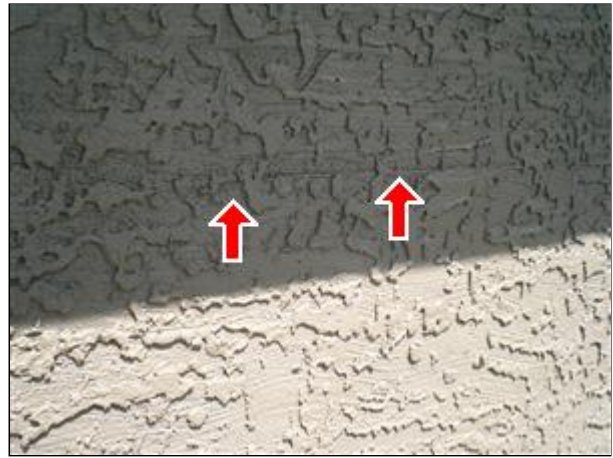
(6) There are several small cracks in the stucco. Recommend qualified stucco contractor repair as needed.

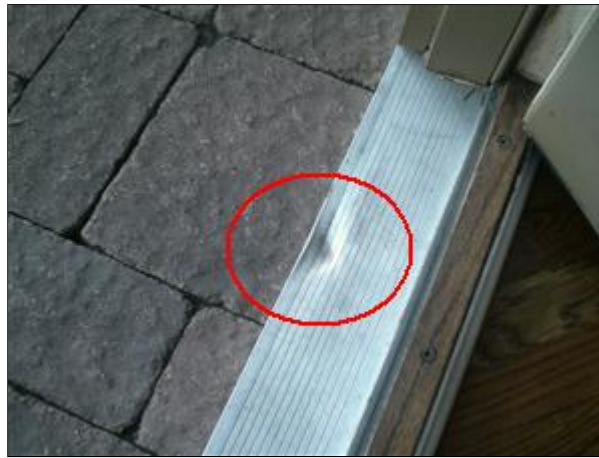
2.1 Picture 1

**Comments:** Inspected, Repair or Replace  
Step plate at rear door is damaged.

10. Step plate at rear door is damaged.

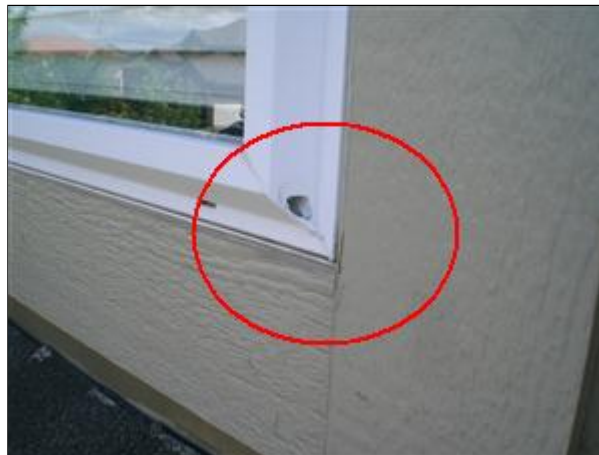
2.2 Picture 1

**Comments:** Inspected, Repair or Replace  
There is a window at the front of the house on the second floor that has hail damage.

11. There is a window at the front of the house on the second floor that has hail damage.

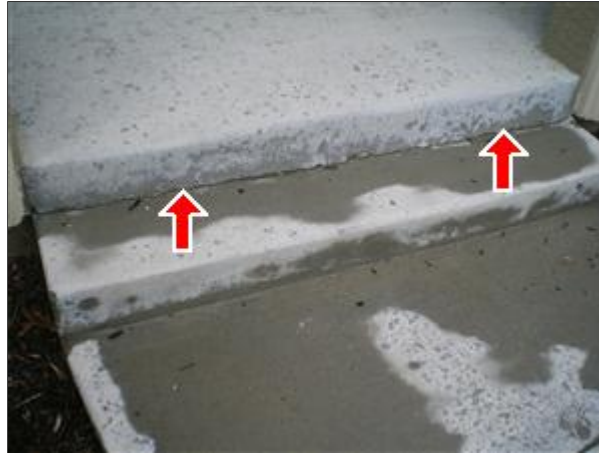
2.3 Picture 1

Crack at front step needs to be sealed.

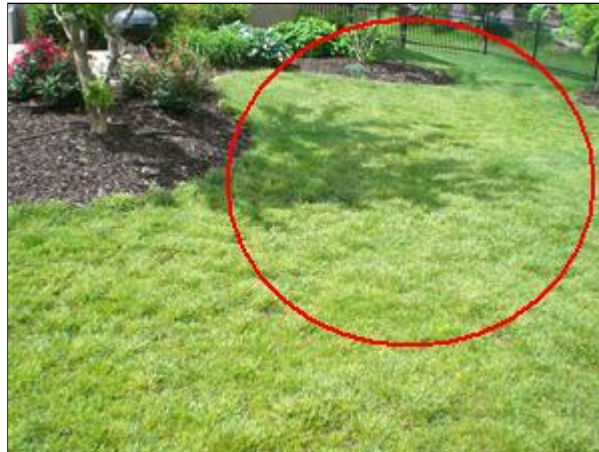
2.4 Picture 1

There is an area in the back yard that was saturated from the morning rain. Because most of the adjacent yards shed water towards this location, I recommend installing a french drain to aid in carrying water towards the street.

12. There is an area in the back yard that was saturated from the morning rain. Because most of the adjacent yards shed water towards this location, I recommend installing a french drain to aid in carrying water towards the street.

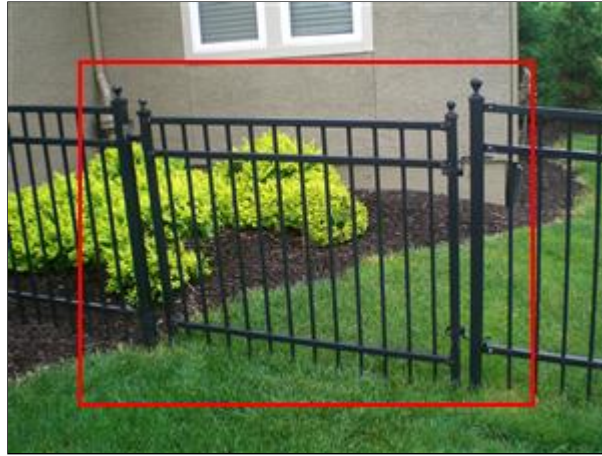
2.6 Picture 1

(1) Fence gate on east side of house needs to be re-hung.

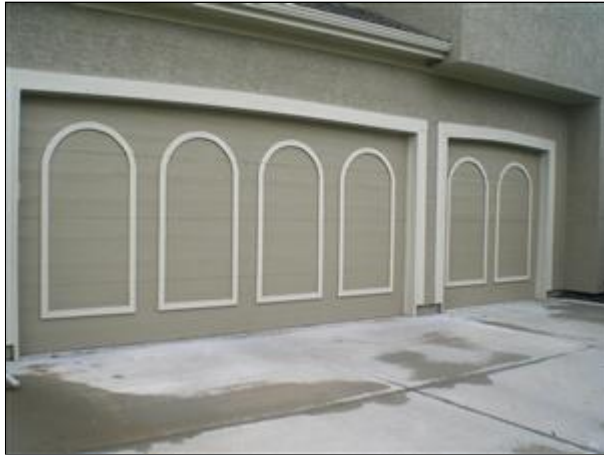
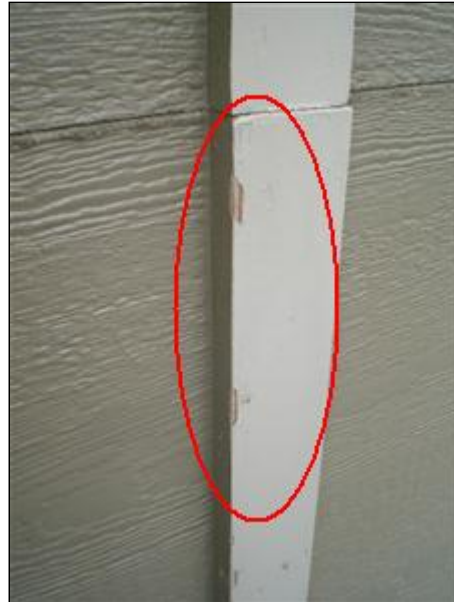
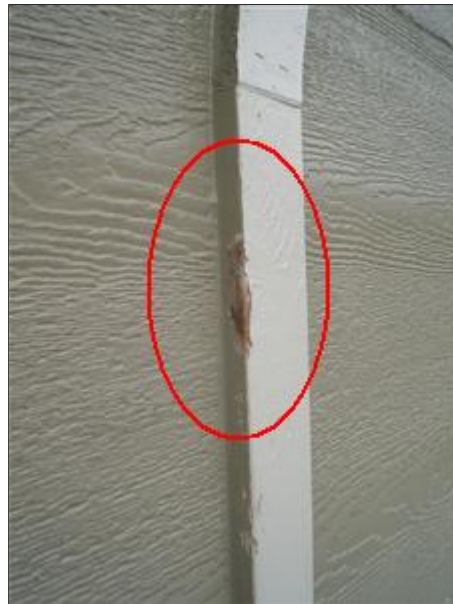
(1) Garage doors have sustained hail damage and need to be repainted.

14. (1) Garage doors have sustained hail damage and need to be repainted.
15. (2) Gap at garage door needs to be sealed.

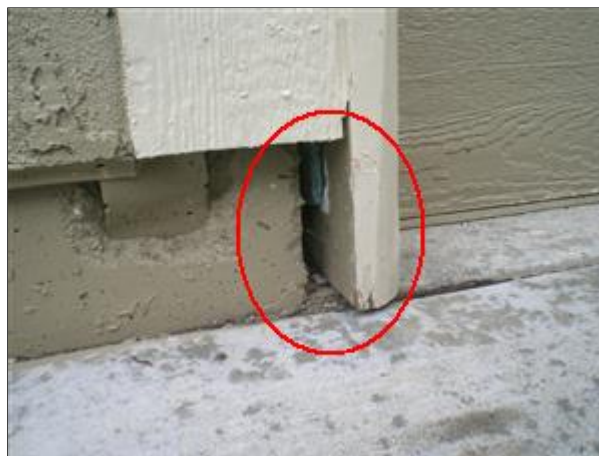
3.3 Picture 4

(2) Gap at garage door needs to be sealed.

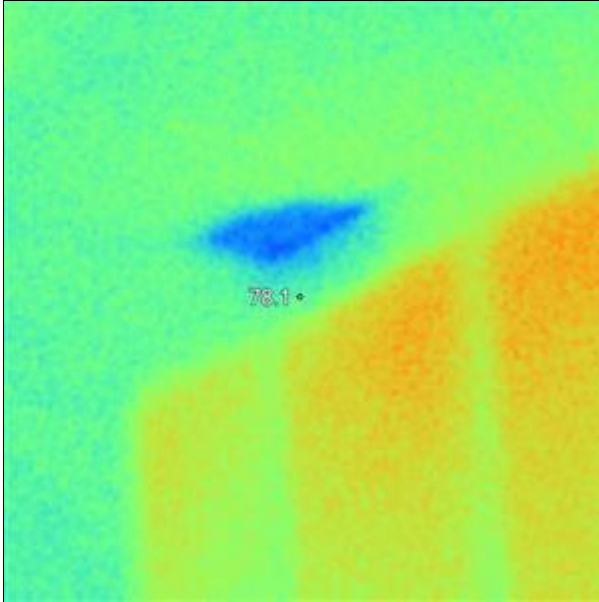
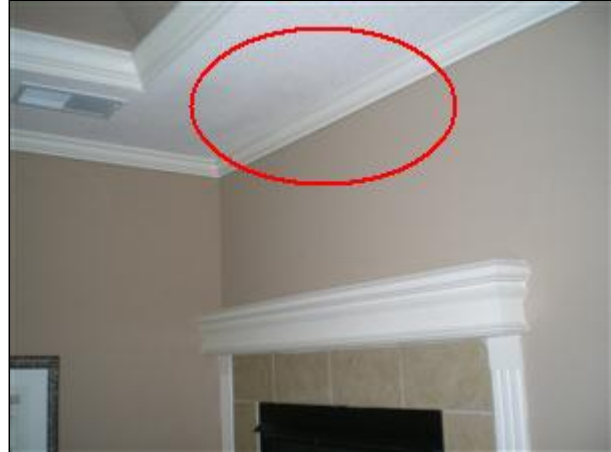
(1) There is evidence of moisture intrusion at the ceiling of the master bedroom. The first photo is a thermal image - the blue areas indicate moisture. The second photo was taken from the same vantage point as the thermal image.

16. (1) There is evidence of moisture intrusion at the ceiling of the master bedroom. The first photo is a thermal image - the blue areas indicate moisture. The second photo was taken from the same vantage point as the thermal image.
17. (2) The seam at the ceiling in the master closet is damaged and needs to be repaired. There are also some nail pops at this area in need of repair.

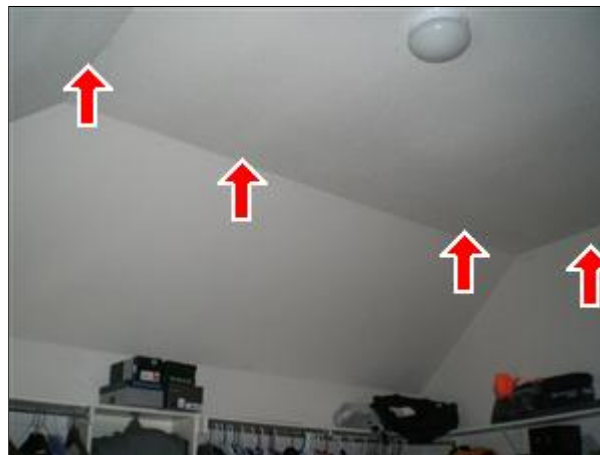
4.0 Picture 3

(2) The seam at the ceiling in the master closet is damaged and needs to be repaired. There are also some nail pops at this area in need of repair.

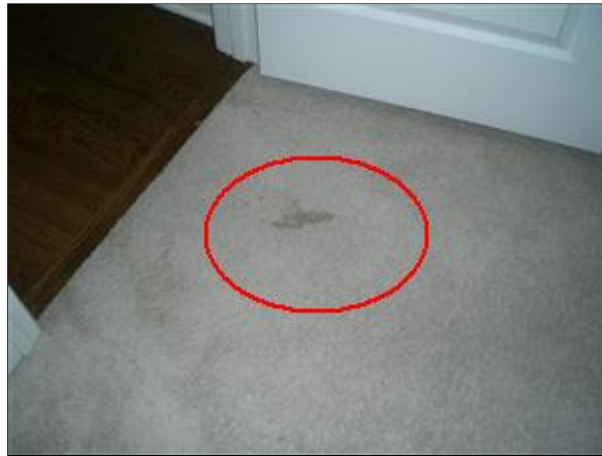
4.2 Picture 1

There was a small stain at the entrance of the first floor office.

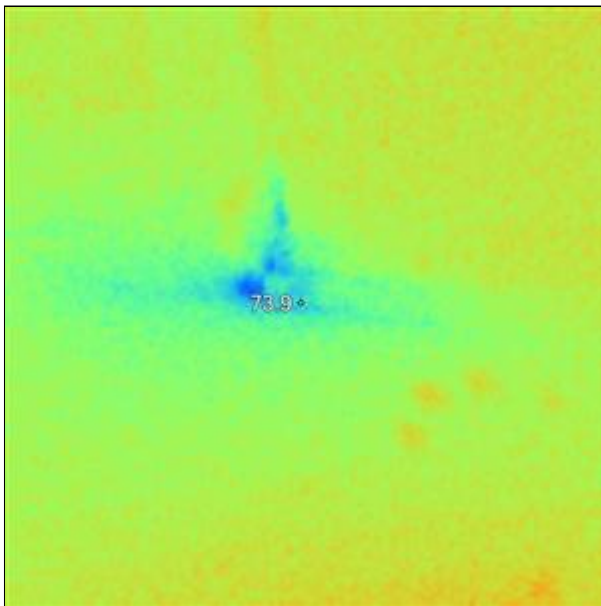
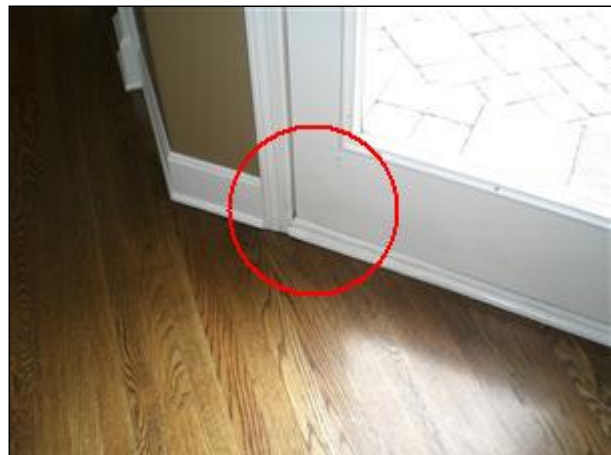
There is evidence of moisture coming at the bottom corners of the exterior door leading to the back patio. The first photo is a thermal image - the blue areas indicate moisture. The second photo was taken from the same vantage point as the thermal image.

18. There is evidence of moisture coming at the bottom corners of the exterior door leading to the back patio. The first photo is a thermal image - the blue areas indicate moisture. The second photo was taken from the same vantage point as the thermal image.

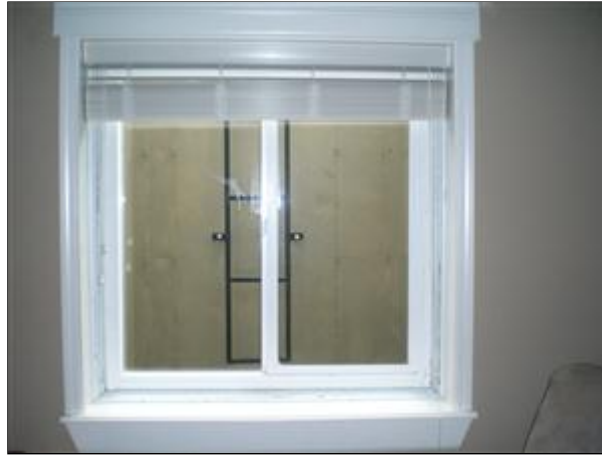
4.6 Picture 1

Basement window is missing screen.

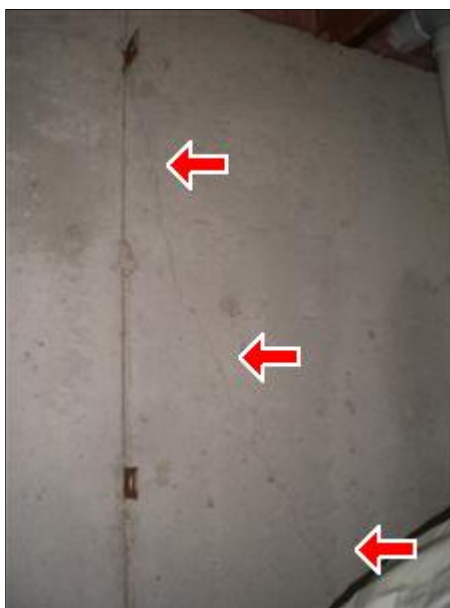
5.0 Picture 1

There was one small foundation crack in the basement storage room to the east. Because the crack is so small at this time I do not recommend any corrective action. The crack should be monitored on a yearly basis for movement. If the crack should ever grow to over a 1/4" in width, an engineer should be consulted. If the drainage issue mentioned in section 2.4 is addressed, this should not turn into an issue.

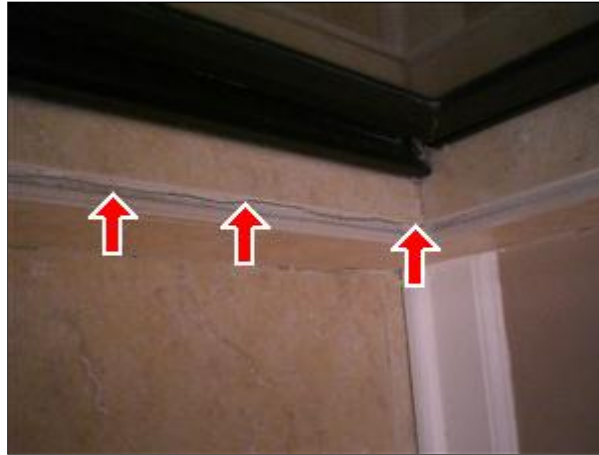
6.1 Picture 1

Need to re-grout tile at entrance of master bathroom shower.

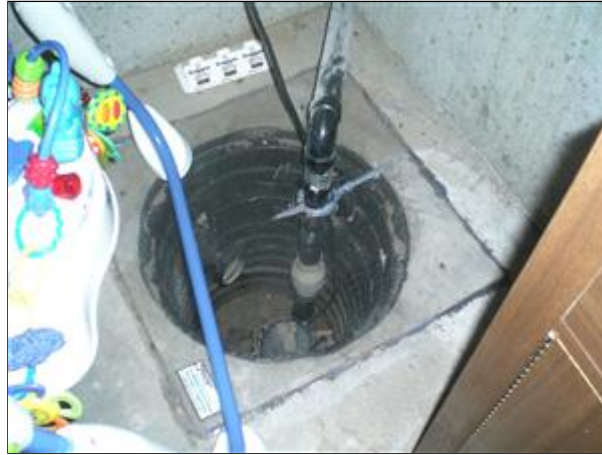
6.6 Picture 1

Sump pump has been sealed to contain radon gas under slab. Pump was operational at time of inspection. Recommend adding a battery backup to protect basement finishes.

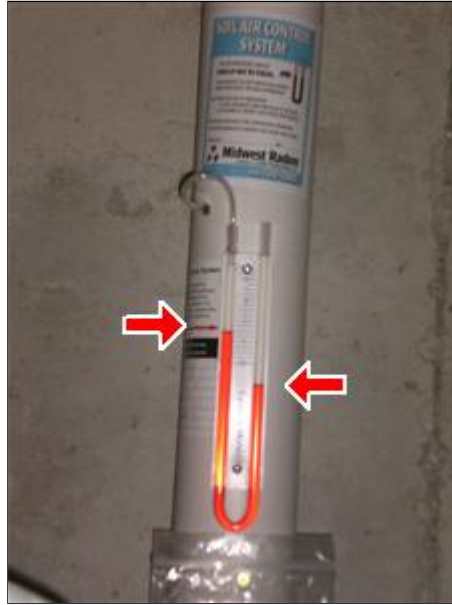
6.8 Picture 1

Radon system was operational at time of the inspection. The unit should be inspected yearly to make sure fan is operating.

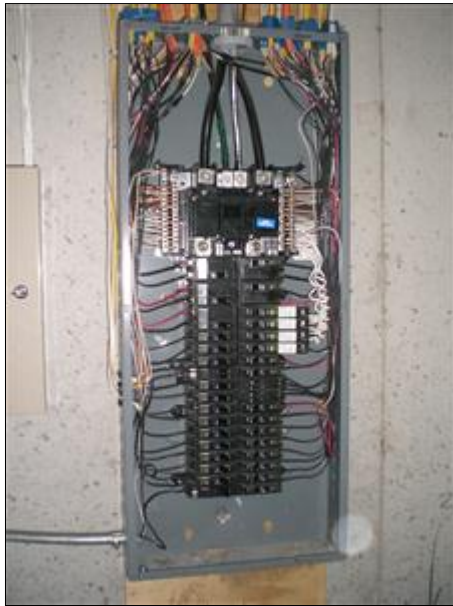
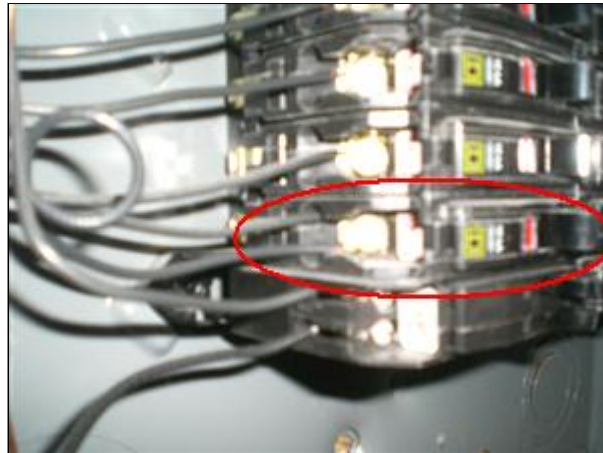
The main panel is located in the basement on the west wall. There was just on issue - one of the breakers that is designed for one wire has two wires connected to it. The circuit breaker needs to be replaced with one that is intended for two wires.

20. The main panel is located in the basement on the west wall. There was just one issue - one of the breakers that is designed for one wire has two wires connected to it. The circuit breaker needs to be replaced with one that is intended for two wires.

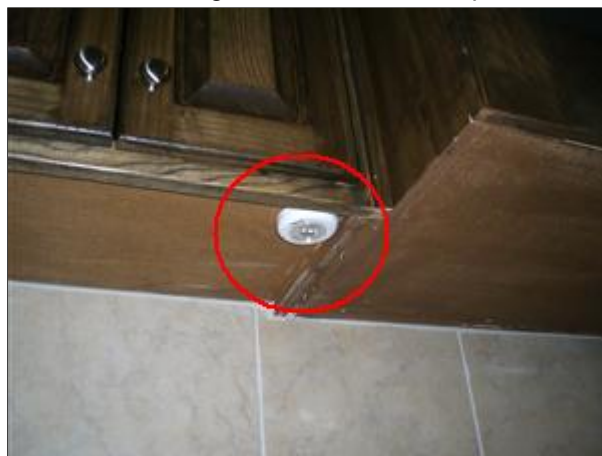
7.3 Picture 1

(1) Puck lights under basement bar were not working at the time of the inspection.

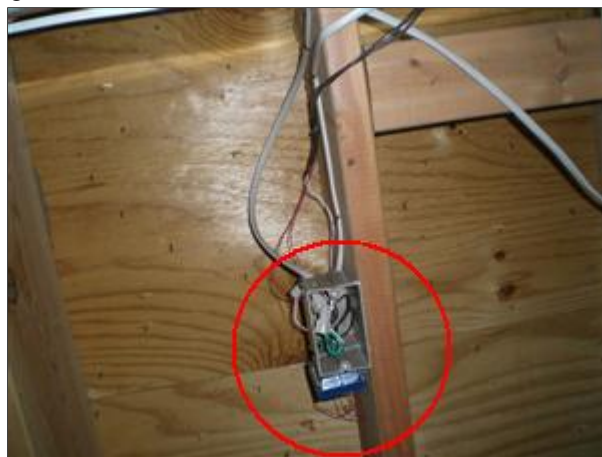
7.3 Picture 2

(2) Junction box in basement storage needs a cover.

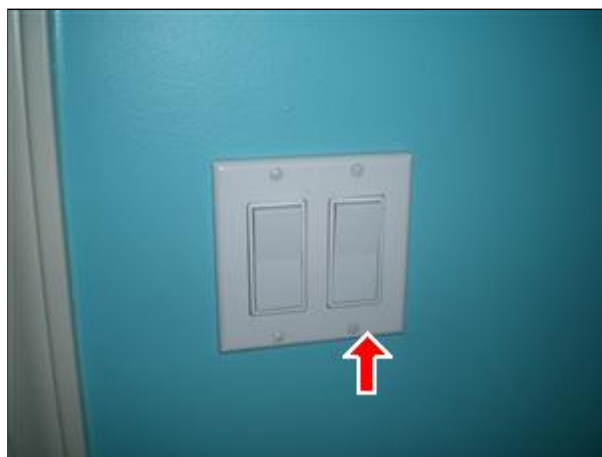
7.3 Picture 3

(3) There are several rooms with two switches. The second switch would operate a ceiling fan if one is installed in the future.

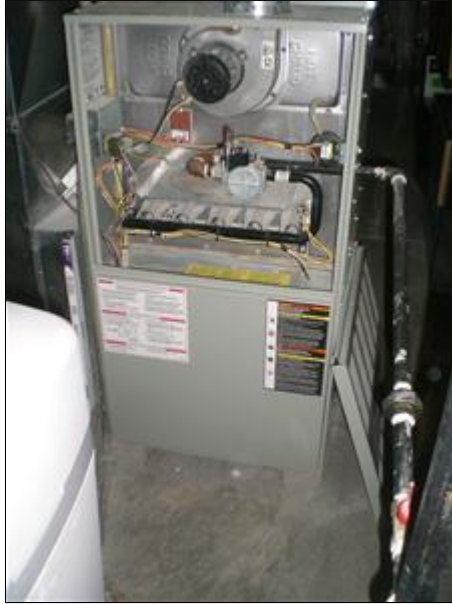
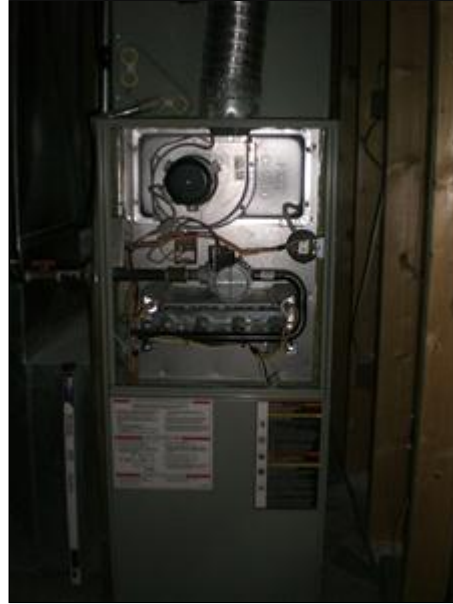
Furnace was operational at the time of the inspection. Both units were manufactured in 2005.

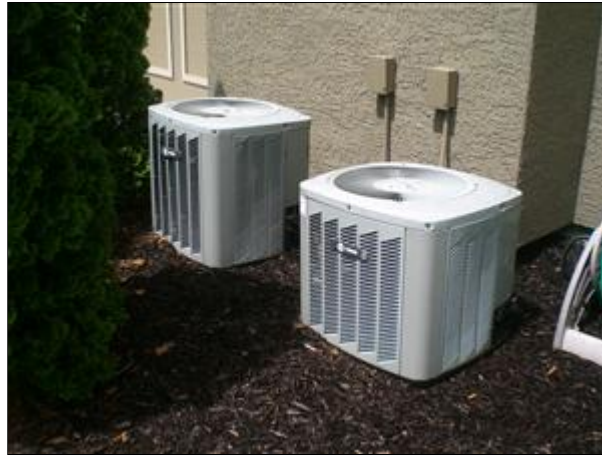
8.8 Picture 1

The ambient air test was performed by using thermometers on the air handler of both Air conditioners to determine if the difference in temperatures of the supply and return air are between 14 degrees and 22 degrees which indicates that the unit is cooling as intended. The supply air temperature on your system read 54 degrees on one unit and on the other one read 55 degrees, and the return air temperature was 74 degrees on one unit and on the other one read 76 degrees. This indicates the range in temperature drop is normal. Both units were manufactured in 2004.

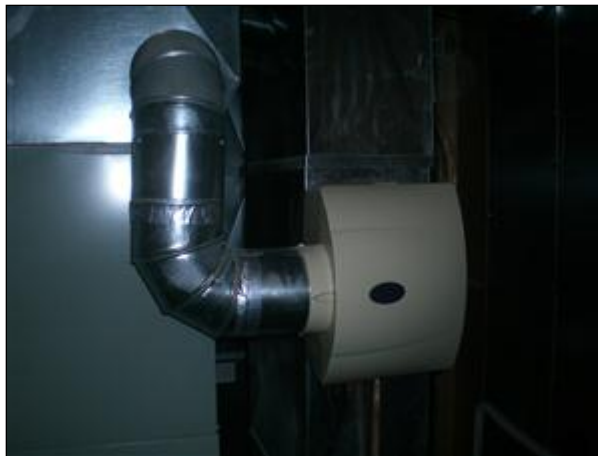
8.11 Picture 1

ESI does not inspect humidification systems. Note that these systems need to be turned on in the winter and off in the summer. On & off is located at the unit. Filter needs to be changed.

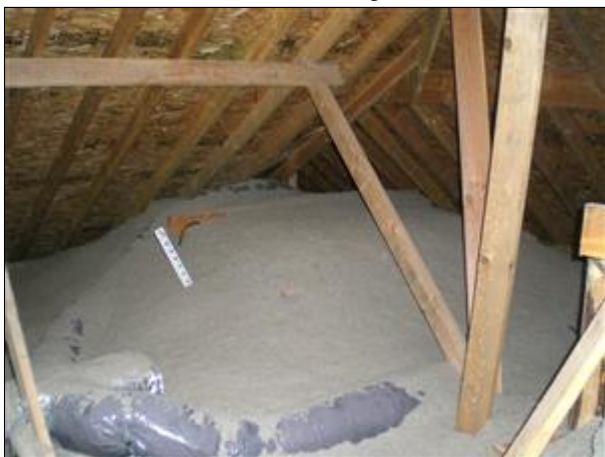
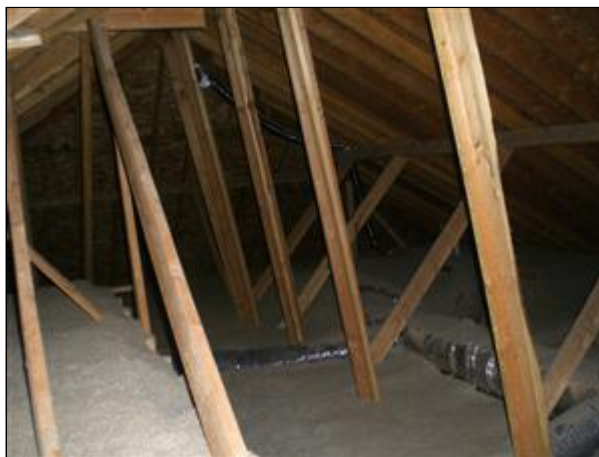
Attic is well insulated. Thickness averages from 12-14".

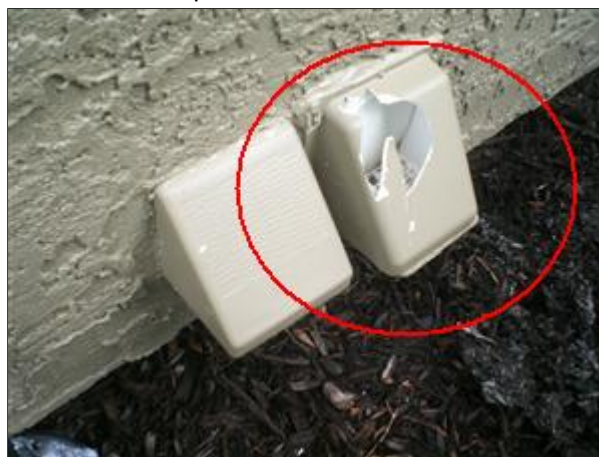
9.3 Picture 1

Exterior dryer vent is damaged and needs to be replaced.

23. Exterior dryer vent is damaged and needs to be replaced.
