Inspection Report

Townhouse
Lenexa KS 12345

ESI Property Inspection

Date: 6/15/2011	Time: 09:00 AM	Report ID: Townhouse
Property: Townhouse Lenexa KS 12345	Customer: Sample Customer 3	Real Estate Professional: World's Best Realtor

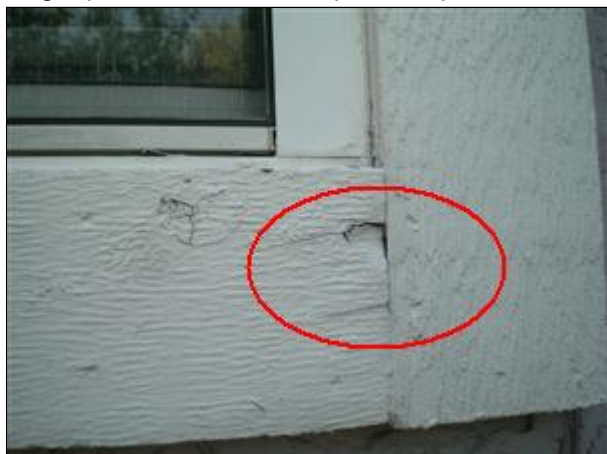
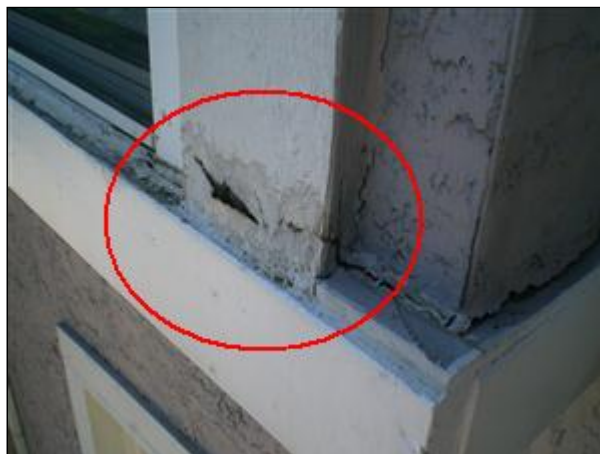
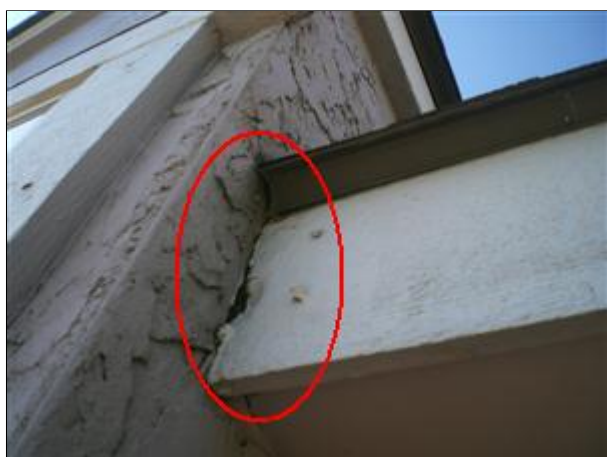
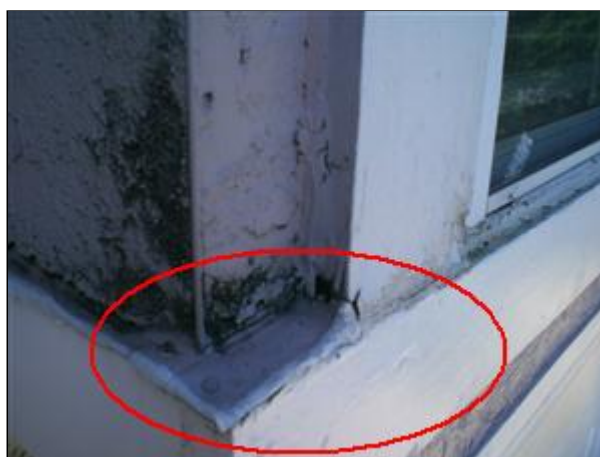
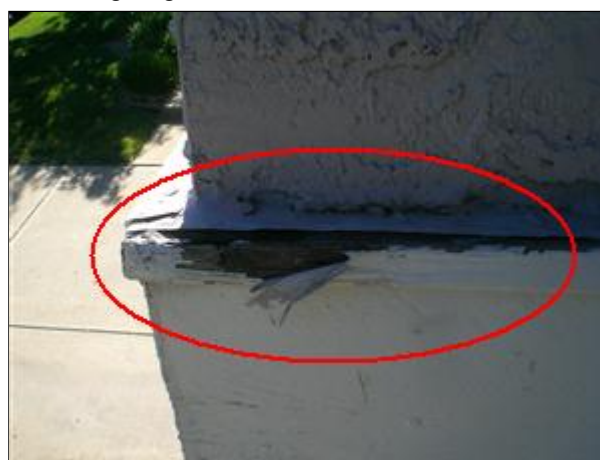
(1) There is some deterioration / wood rot at some trim and at windows at the front of the house. Recommend trim above garage qualified contractor repair or replace as needed.

2.0 Picture 1 window at west side of house

2.0 Picture 2 window above garage

2.0 Picture 3 trim above garage

2.0 Picture 5 Trim above garage

1. (1) There is some deterioration / wood rot at some trim and at windows at the front of the house. Recommend trim above garage qualified contractor repair or replace as needed.
2. (2) There are several areas where gaps between the trim and stucco siding need to be caulked and sealed.
3. (3) There is cracking in stucco siding in several areas. The west side at the south west corner and the chimney are two areas the I noticed. Stucco cracks need to be sealed because they allow water enter the structure. Recommend qualified contractor repair stucco as needed.
4. (4) There is a deteriorated section of trim on the east side of the house that needs to be repaired. Recommend qualified contractor repair or replace as needed.

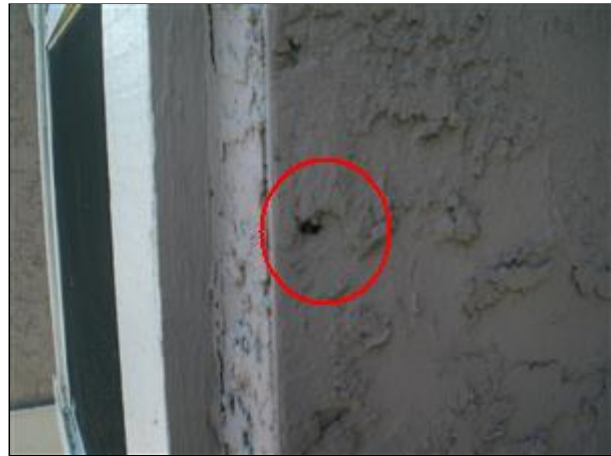
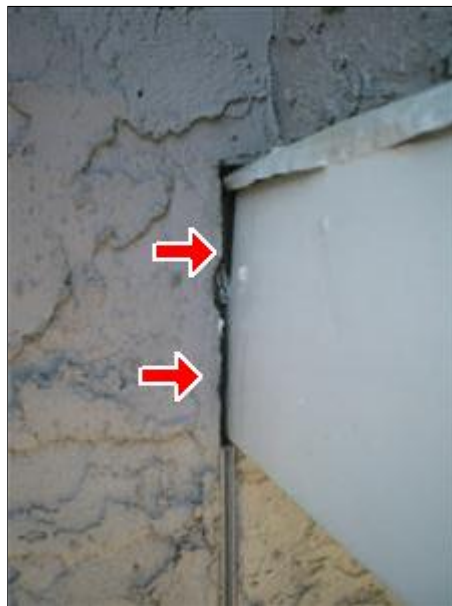
(2) There are several areas where gaps between the trim and stucco siding need to be caulked and sealed.

2.0 Picture 6 caulk

2.0 Picture 7 seal small hole above garage

2.0 Picture 8 caulk

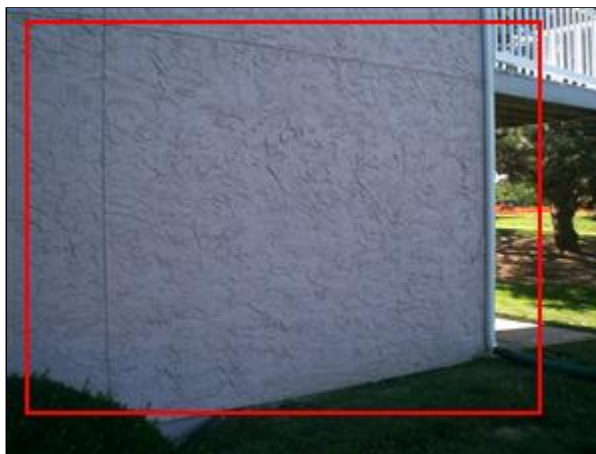
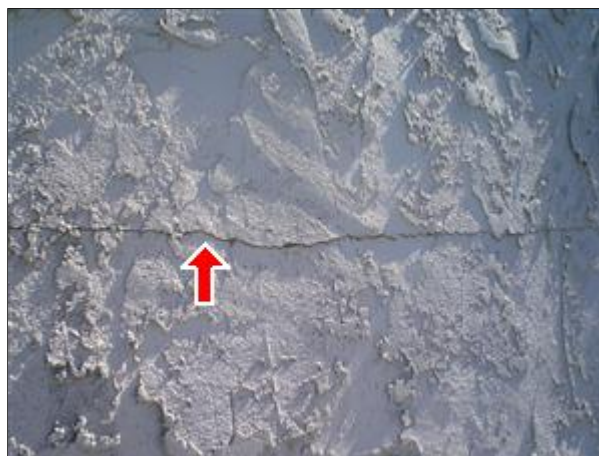
(3) There is cracking in stucco siding in several areas. The west side at the south west corner and the chimney are two areas the I noticed. Stucco cracks need to be sealed because they allow water enter the structure. Recommend qualified contractor repair stucco as needed.

2.0 Picture 9 several cracks at the west side

2.0 Picture 10 several cracks

2.0 Picture 11 crack at chimney

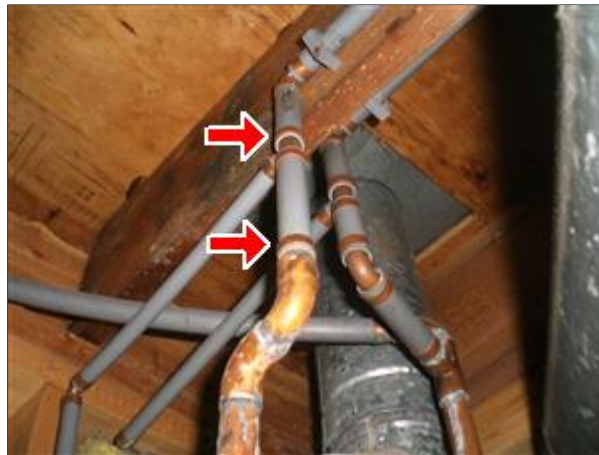
6.1 Picture 1

(1) Polybutylene plastic plumbing supply lines (PB) are installed in the subject house. Polybutylene has been used in this area for many years, but has had a higher than normal failure rate, and is no longer being widely used. Copper and Brass fittings used in later years have apparently reduced the failure rate. This subject house has copper fittings.

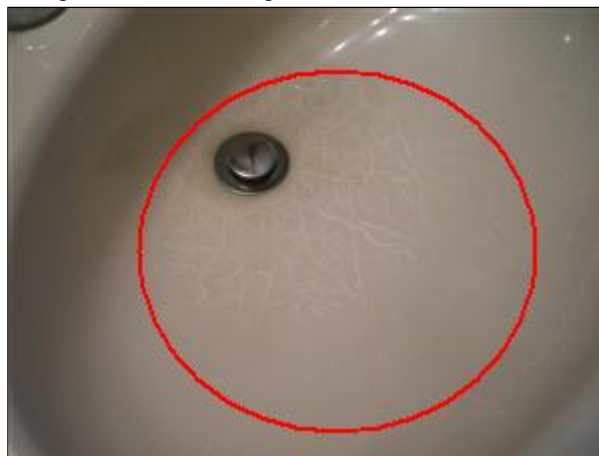
6.1 Picture 2

(2) There are several sinks that are starting to show some cracking at the time of the inspection. None were leaking at the inspection. Recommend monitoring for future leaking.

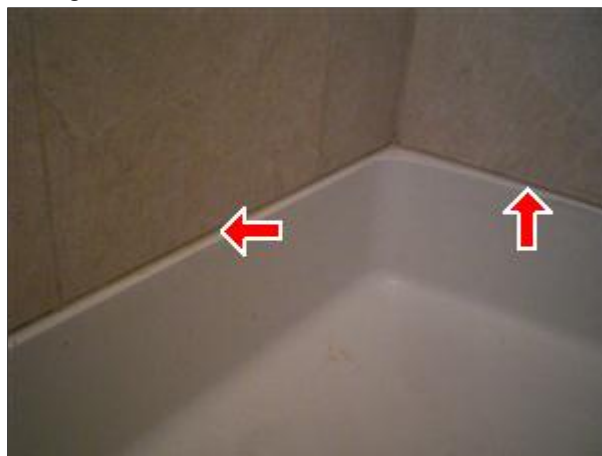
6.1 Picture 3

(3) Recommend caulking the bottom edge of the master bathroom shower.

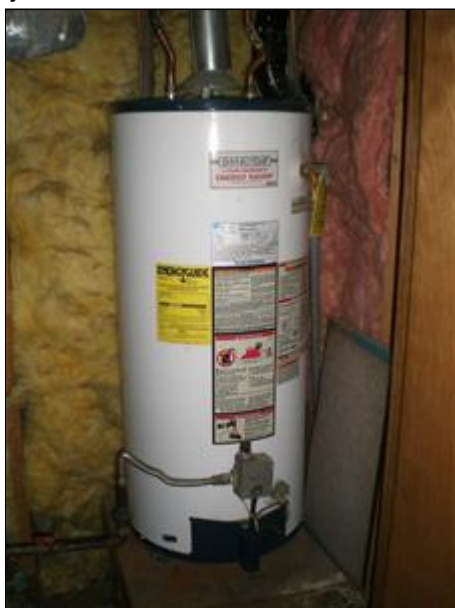
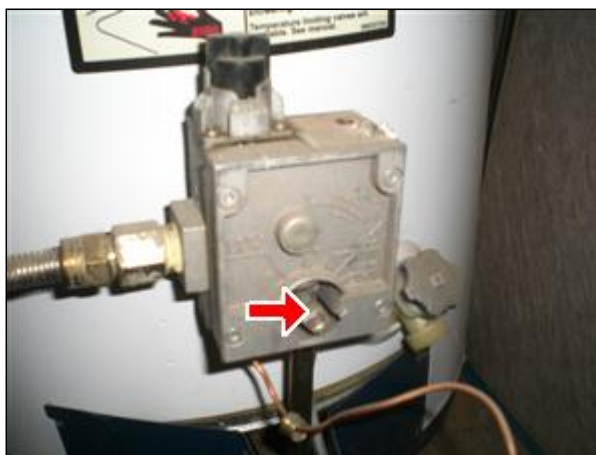
Hot water heater was operational at time of inspection. Manufactured in 2001. The hot water heater was missing the temperature adjustment dial.

6.2 Picture 2 missing adjustment dial

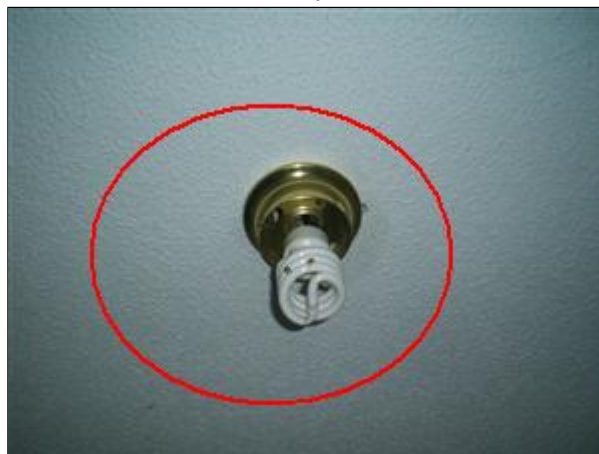
7.3 Picture 1

(1) By modern standards, exposed bulbs in closets are considered a safety hazard and should be replaced with an enclosed fixture. Several of the closets in this house have exposed bulb fixtures.

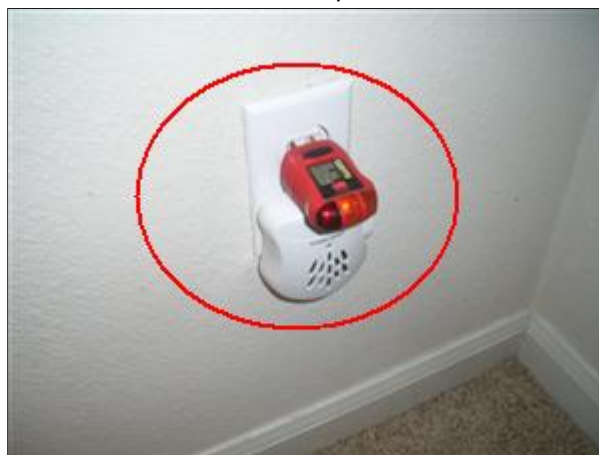
7.3 Picture 2

(2) There are several outlets that have the hot and neutral reversed. One is located on the east wall in the dining room, one in the north west bedroom on the east wall. Recommend qualified electrician service as needed.

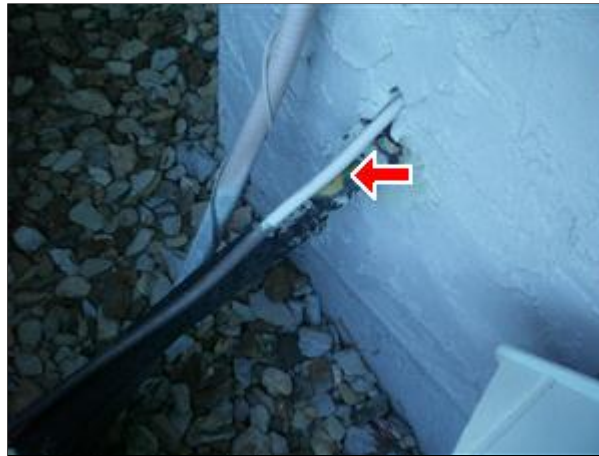
8.7 Picture 2

(2) Insulating foam at outside AC lines needs to be replaced
